IMMEDIATE  
SERVICE  
NOTICE

NO. 179A

SUBJECT  
2236 MXD AT 19.2K BAUD. ECN'S

THIS ISN REPLACES ISN 179.

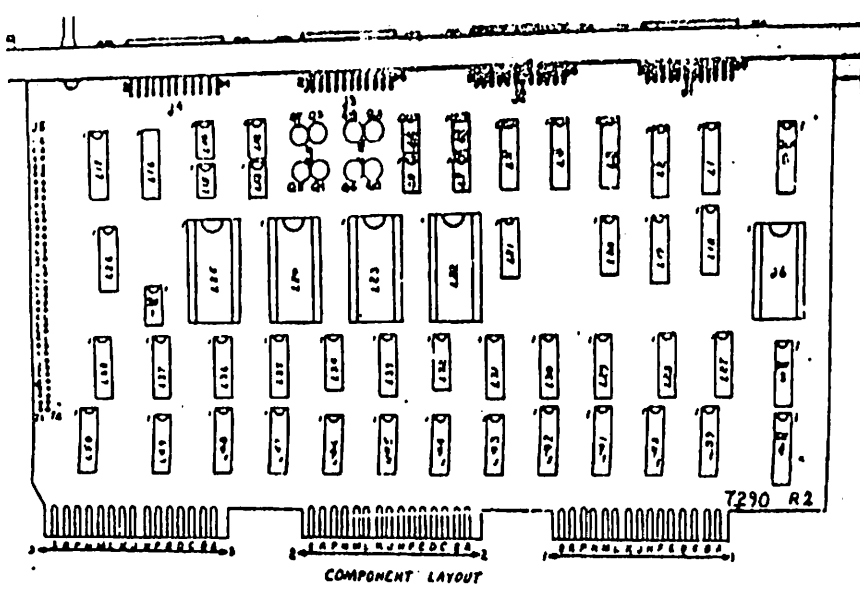
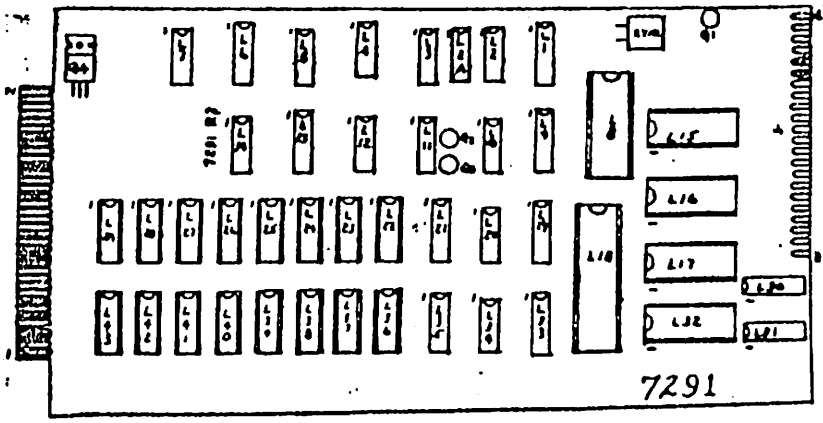
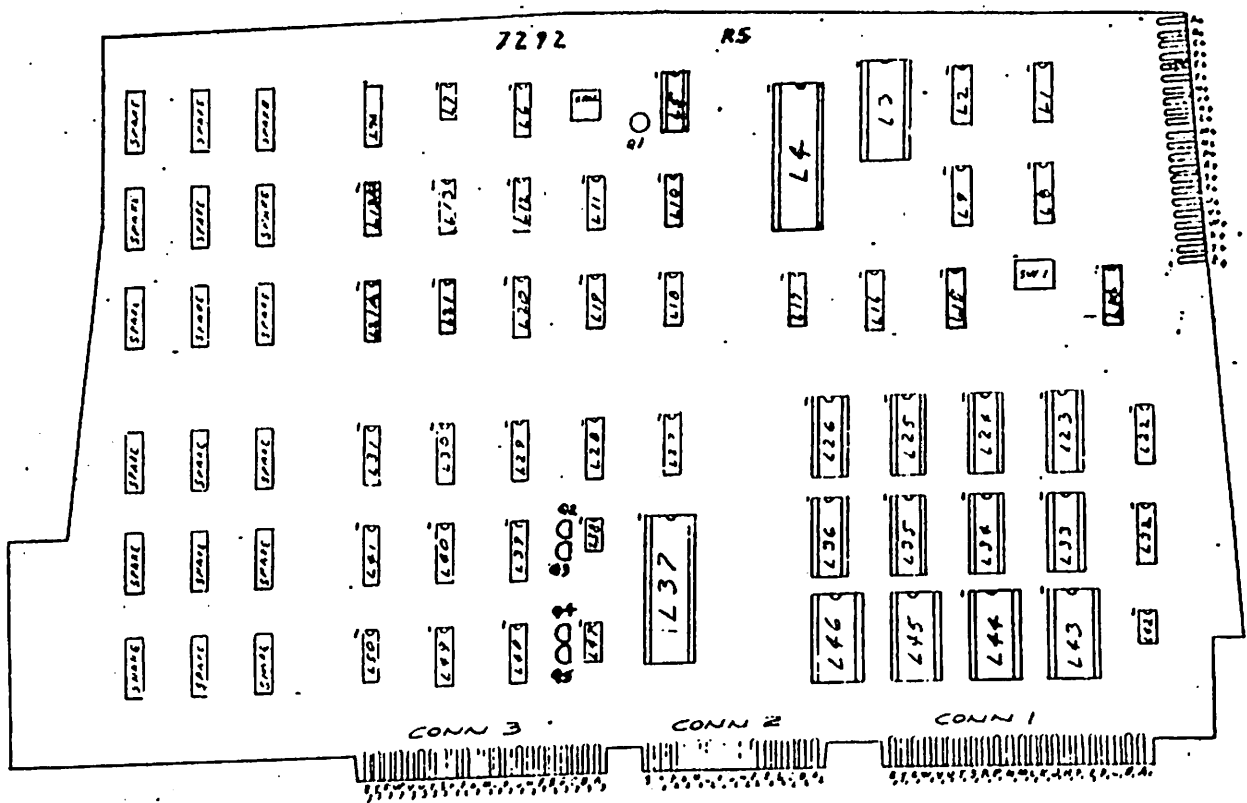
1. 210-7290-1 (ECN 9447)

1. This prevents the controller from operating at 4800 baud.
2. On new production boards a jumper has been installed between L18 and L19 to facilitate the change from 4800 to 19.2K or vice versa. The three plate-throughs for the jumper are layed out vertically with the common point in the center. The top plate-through is for 19.2K and the bottom for 4800.
3. Since 19.2K takes the place of 4800, the baud rate switches must be set for 4800 to allow 19.2K operation.

- A. Isolate L19 pin 11 from the etch that connects it to the baud rate switches.
- B. Tie L19 pin 13 to the etch that was connected to L19 pin 11.
- C. Change E-REV from 0 to 1.

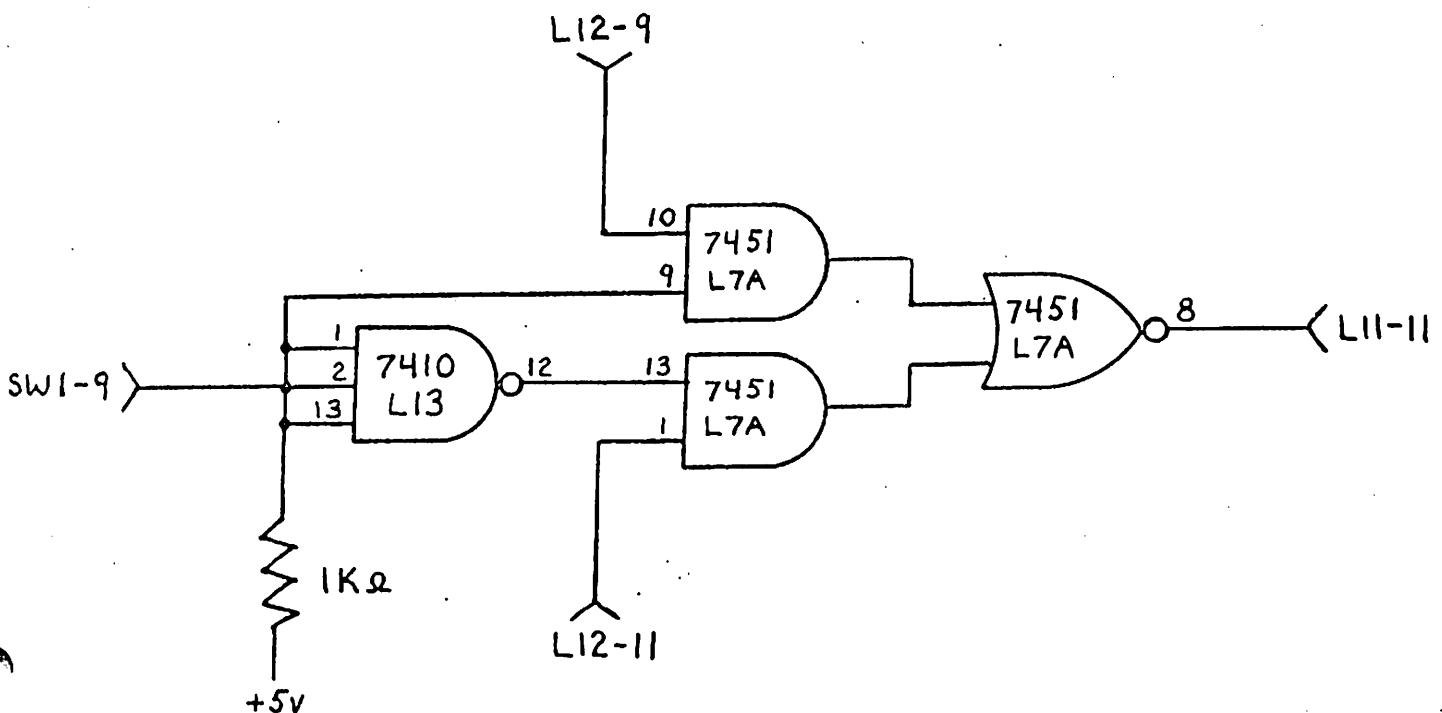
2. 210-7292-1 (ECN 9210)

- A. Cut etch connecting L12 pin 9 to L11 pin 11.
- B. Add the circuitry shown below, using a 7451 I.C. (376-0012).
- C. Change E-REV from 3 to 4.

1. If location 7A is occupied by a 74175, return the board to the Home Office.
2. The square plate through designating pin 1 of SW 1 is actually pin 6.

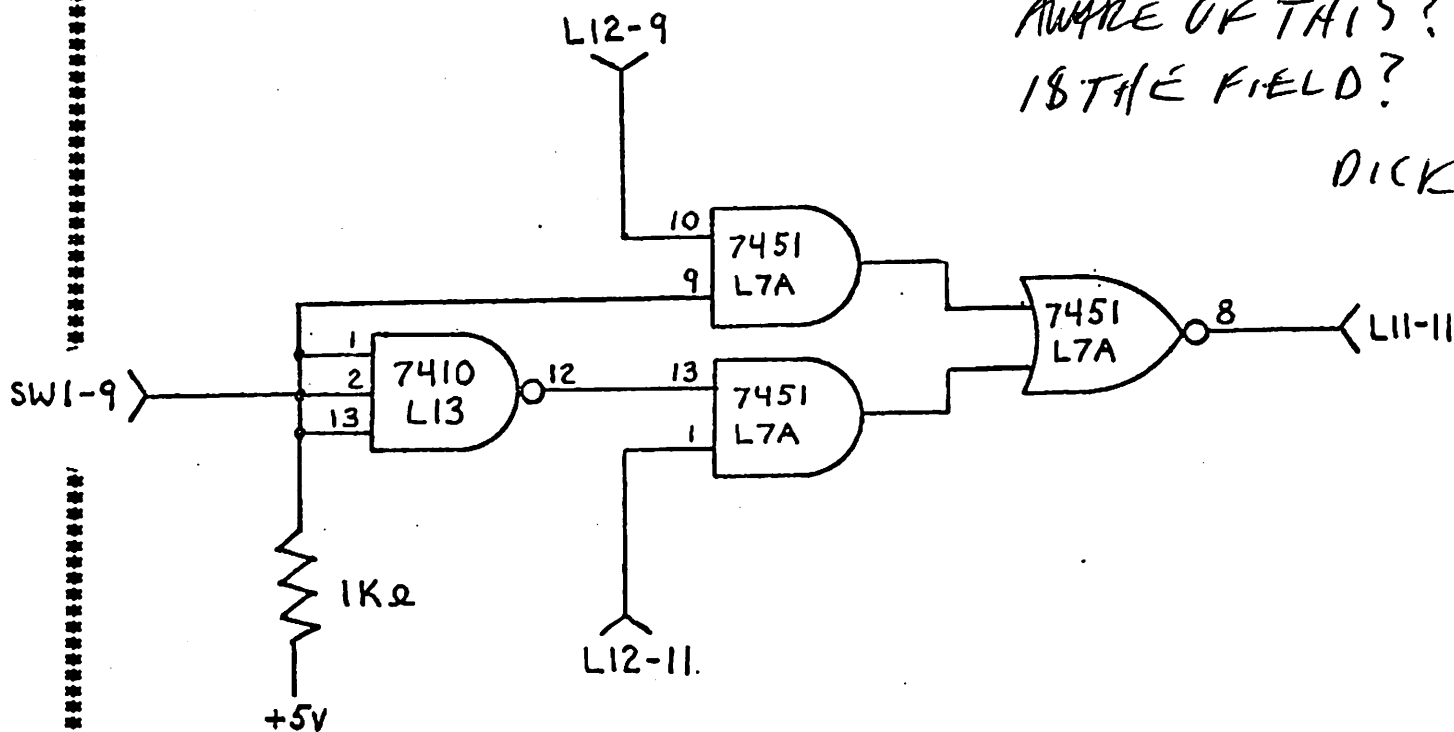
Figure A: Added Circuitry of ECN 9210 for the 210-7292-1

Recently it has been determined that a few 210-7292-1 PCB's presently released to the field from the Home Office have been updated incorrectly. Referring to ISN #179A - Section 1 and Figure A below, the error involves ECN #9210 and is as follows:

The wire connected from L12 pin 9 may be found connected to L7A pin 1. This wire should be connected to L7A pin 10.

Similarly, the wire connected from L12 pin 11 may be connected to L7A pin 10. This wire should be connected to L7A pin 1.

- L12 pin 9 is connected to L7A pin 10
- L12 pin 11 is connected to L7A pin 1
