## 2280 DPU HARDWARE

### PROBLEMS:

I-90 ERRORS, DPU/SYSTEM HANGS, INCORRECT DRIVE SELECTED.

**WANG****ECO****ECO NO. 36643**

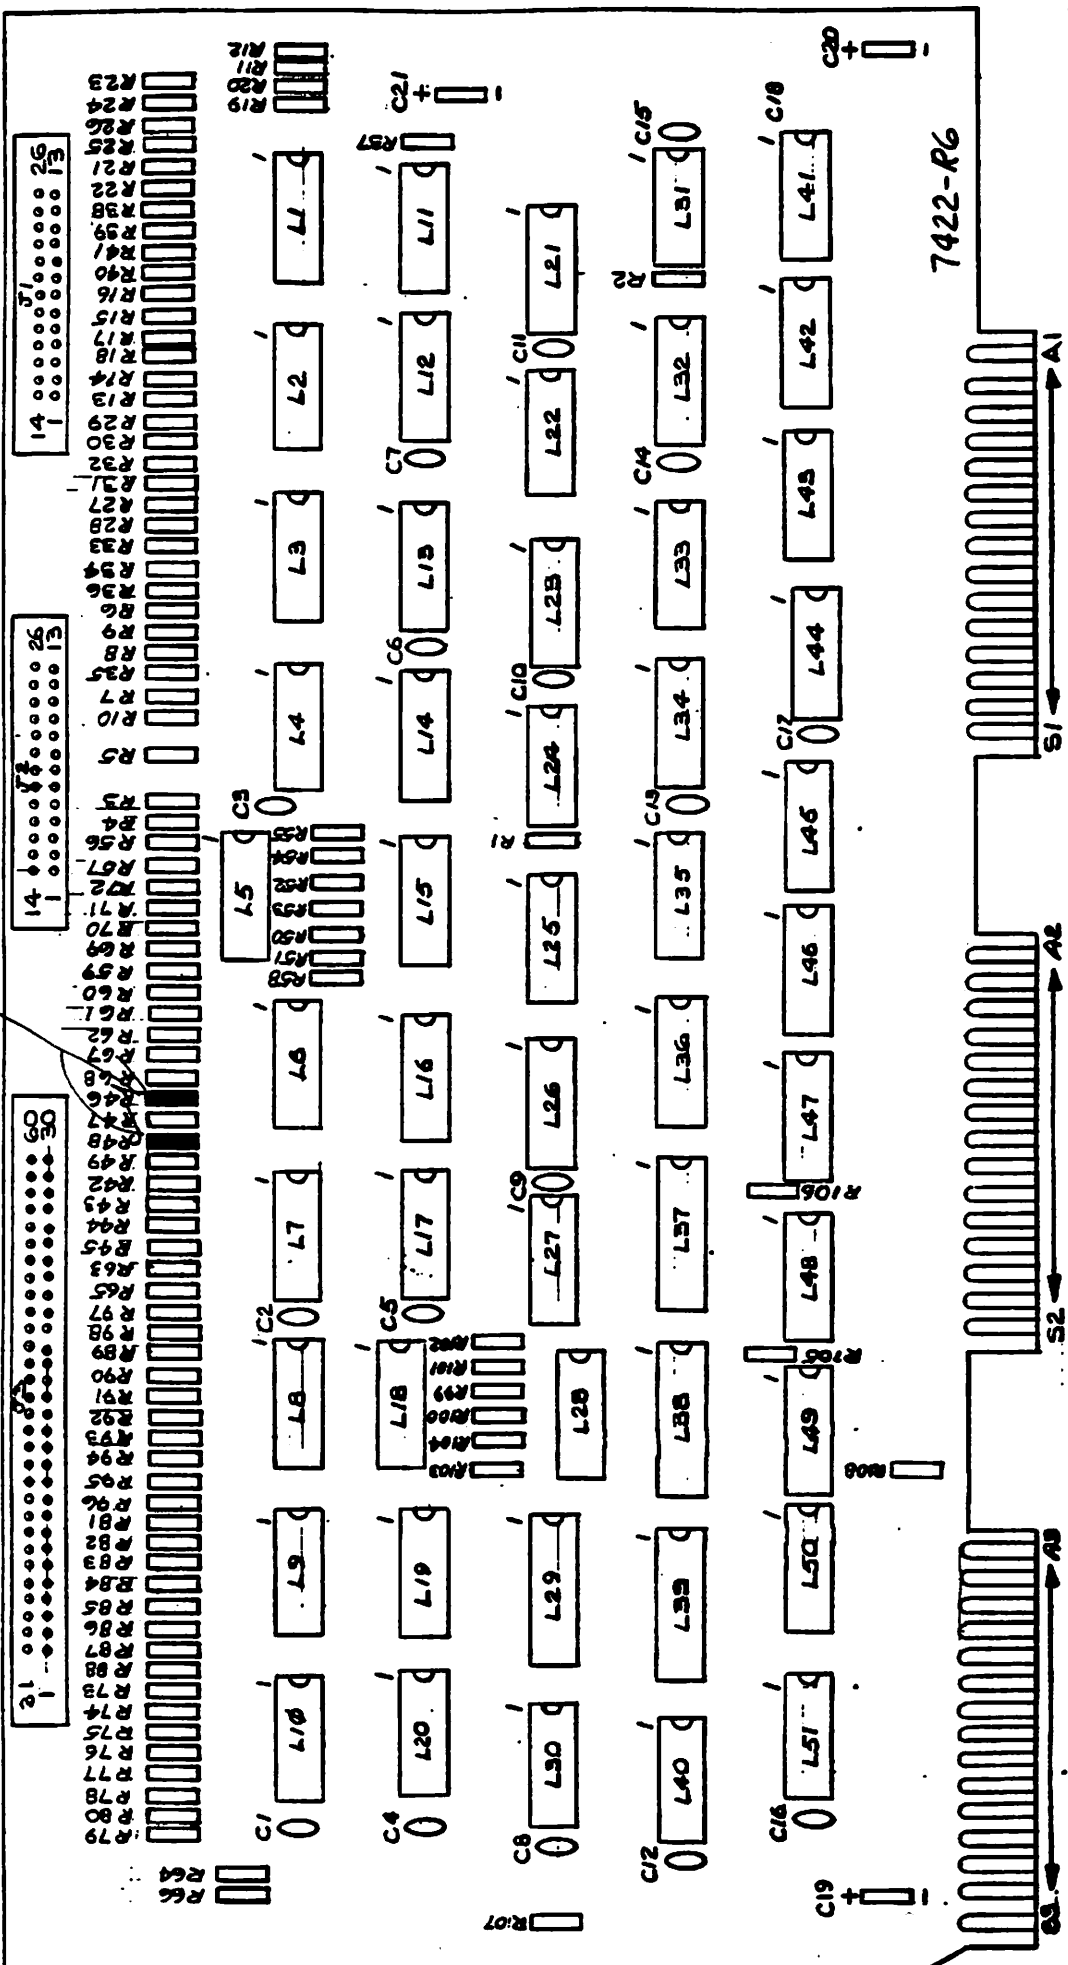
SOURCE OF PROBLEM WAS DUE TO NOISE ON THE (READY LINE) AND ON THE (ON CYLINDER LINE) FROM THE DRIVES TO THE DPU. NOISE ON THESE LINES EXTENDED BEYOND THE 4 us READY SIGNAL OF DRIVE 1 INTO THE AREA OF WHERE THE DRIVE 2 READY SIGNAL WOULD BE. THIS CAUSED SELECTION OF DRIVE #2 TO TAKE PLACE. IF THIS HAPPENS AND DRIVE 2 IS NOT AVAILABLE, THE SYSTEM HANGS. IF THE DRIVE IS AVAILABLE, THEN DATA IS READ FROM OR WRITTEN TO DRIVE 2 CAUSING DATA INTEGRITY PROBLEMS.

DRIVER/RECEIVER CIRCUITS ARE BALANCED LINE TYPE WITH AN UNBALANCED INPUT SIGNAL WHICH DEFEATS NOISE IMMUNITY IN THE DIFFERENTIAL AMPLIFIER INPUTS. (SIGNAL BALANCE VARIATIONS ARE CAUSED BY TERMINATORS, CABLES AND CIRCUIT BOARDS. TERMINATORS SHOWED SIGNAL VARIATIONS OF AS MUCH AS 160 MILLIVOLTS AT THE RECEIVER INPUTS).

CHANGE TERMINATION RESISTORS ON 210-7422 BOARD AT LOCATIONS R46 AND R48. RESISTORS WERE CHANGED FROM 56 OHMS TO 510 OHMS.

Change R-46 + R-48 to 50 ohm Resistors

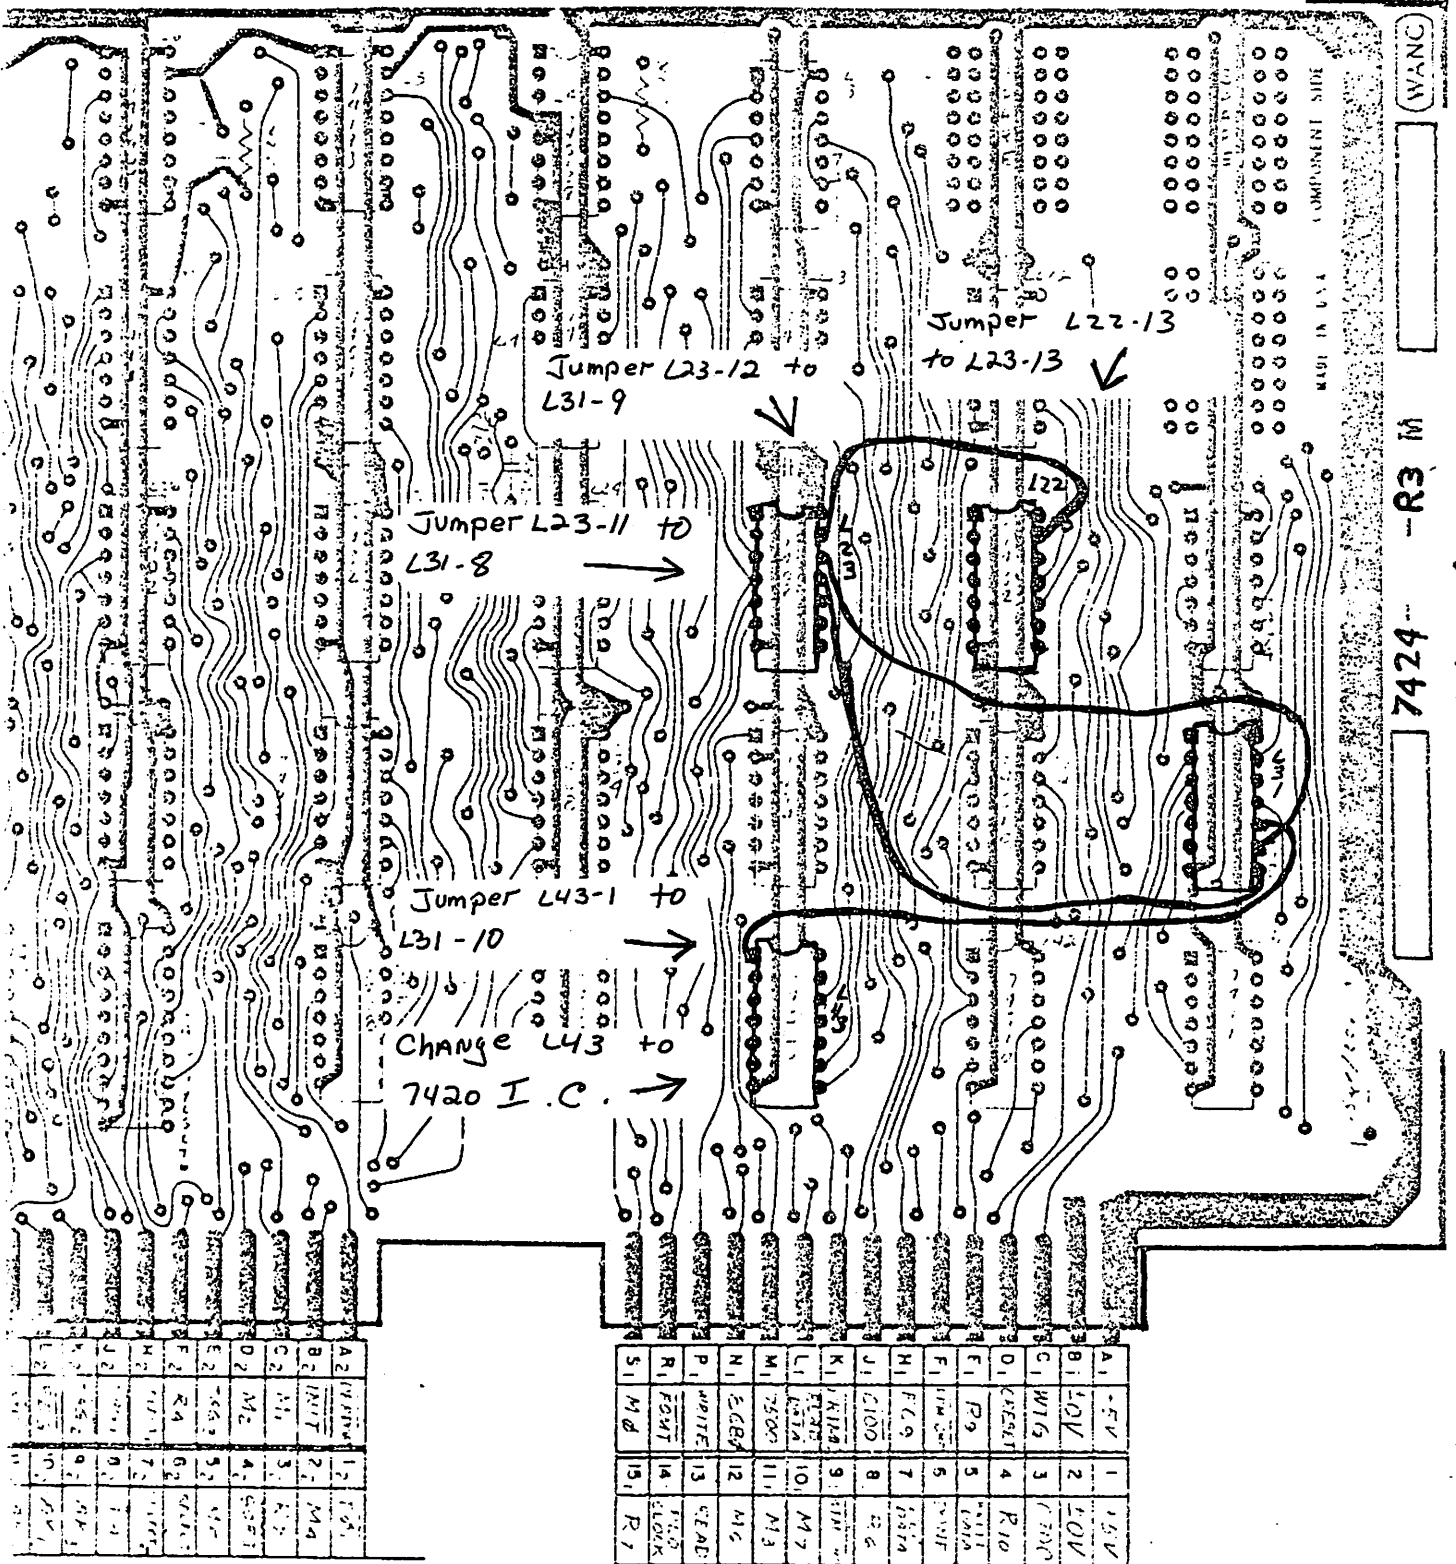
NOISE ON SYNC-BYTE CAN CAUSE FORMAT ERRORS.

Jumper L23-12 to L31-9

Jumper L22-13 to L23-13

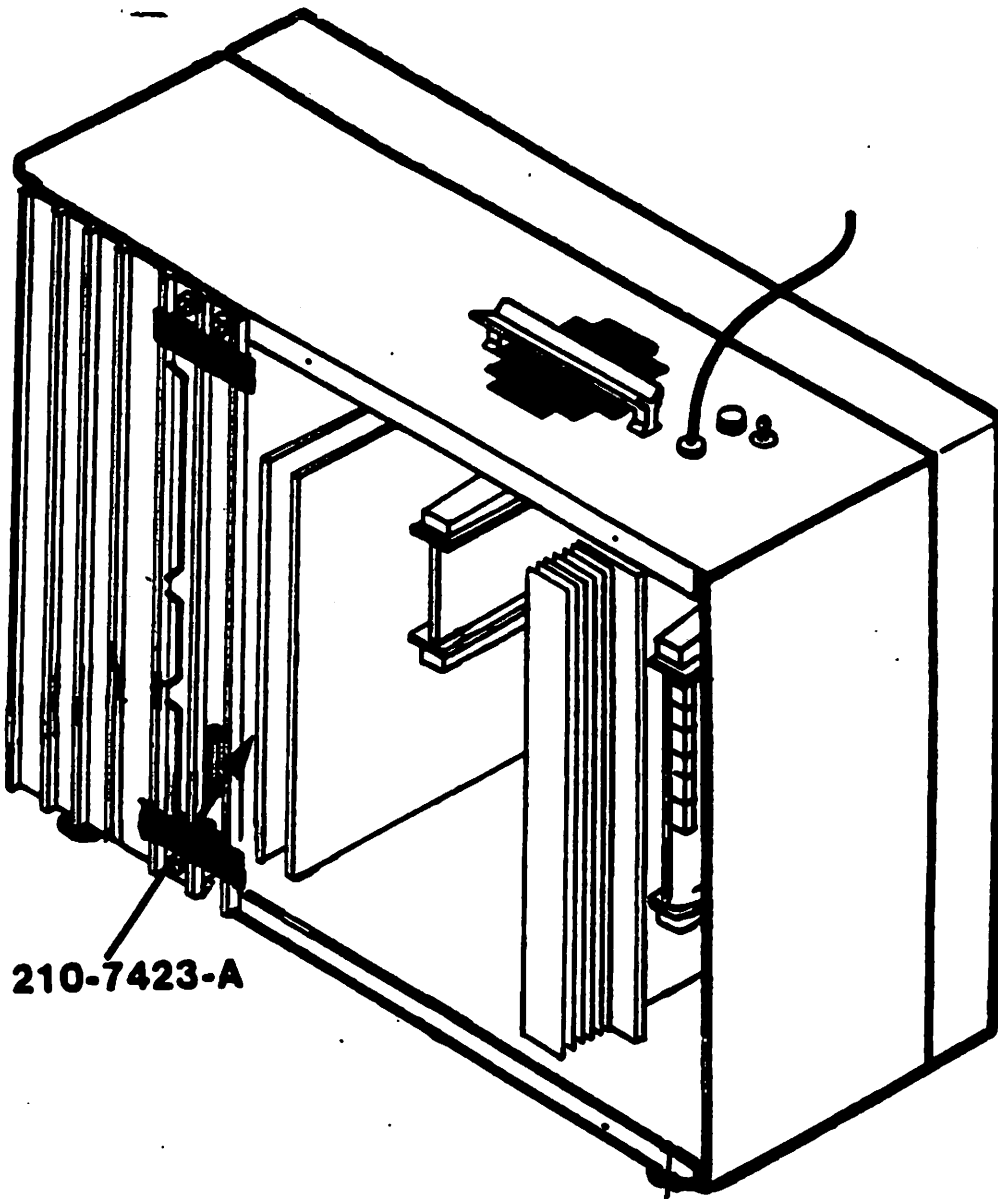
FIGURE 1: CIRCUIT BOARD LOADING

- A. Multi-sector writes that end on relocated alternate sectors can cause extra sectors to be written.
- B. When the first operation of a DPU is multi-sector write, the DPU will return an I91 on this and all other subsequent requests. The I91 will be returned until a reset is issued followed immediately by a non-multisector write operation.
- C. The DPU will hang if a data transmission error occurs during the "Compare" sequence of a "Read After Write" command.
- D. Attempts to access the drive while it was seeking to track "0" during the power-up (or spin-up) sequence causes the drive to retry the seek. If this happens several times in a row, the drive will hang and have to be shut down to clear the condition.

- A. Power off. Remove AC plug at wall.
- B. Refer to the Customer Engineering Product Maintenance Manual, "2280 DPU" (729-0971) p. 4.3, sections 4.5 through 4.5.1 for top cover removal/replacement procedures.
- C. Refer to Figure 1. Remove the 210-7423-A PCB from the Disk Processing Unit (DPU).
- D. Refer to Figure 2. Change the four EPROM's on the 210-7423-A PCB as follows:
  1. Component Side:
    - a. Change L13 to 378-4083-R10.
    - b. Change L14 to 378-4084-R10.
    - c. Change L15 to 378-4085-R10.
    - d. Change L16 to 378-4086-R10.
- E. Reassemble the unit by reversing the procedures in Steps B through D.
- F. Perform check-out procedure described in Section 6 below.
- G. Document installation of this FCO by completing a Call Report or Activity Report.

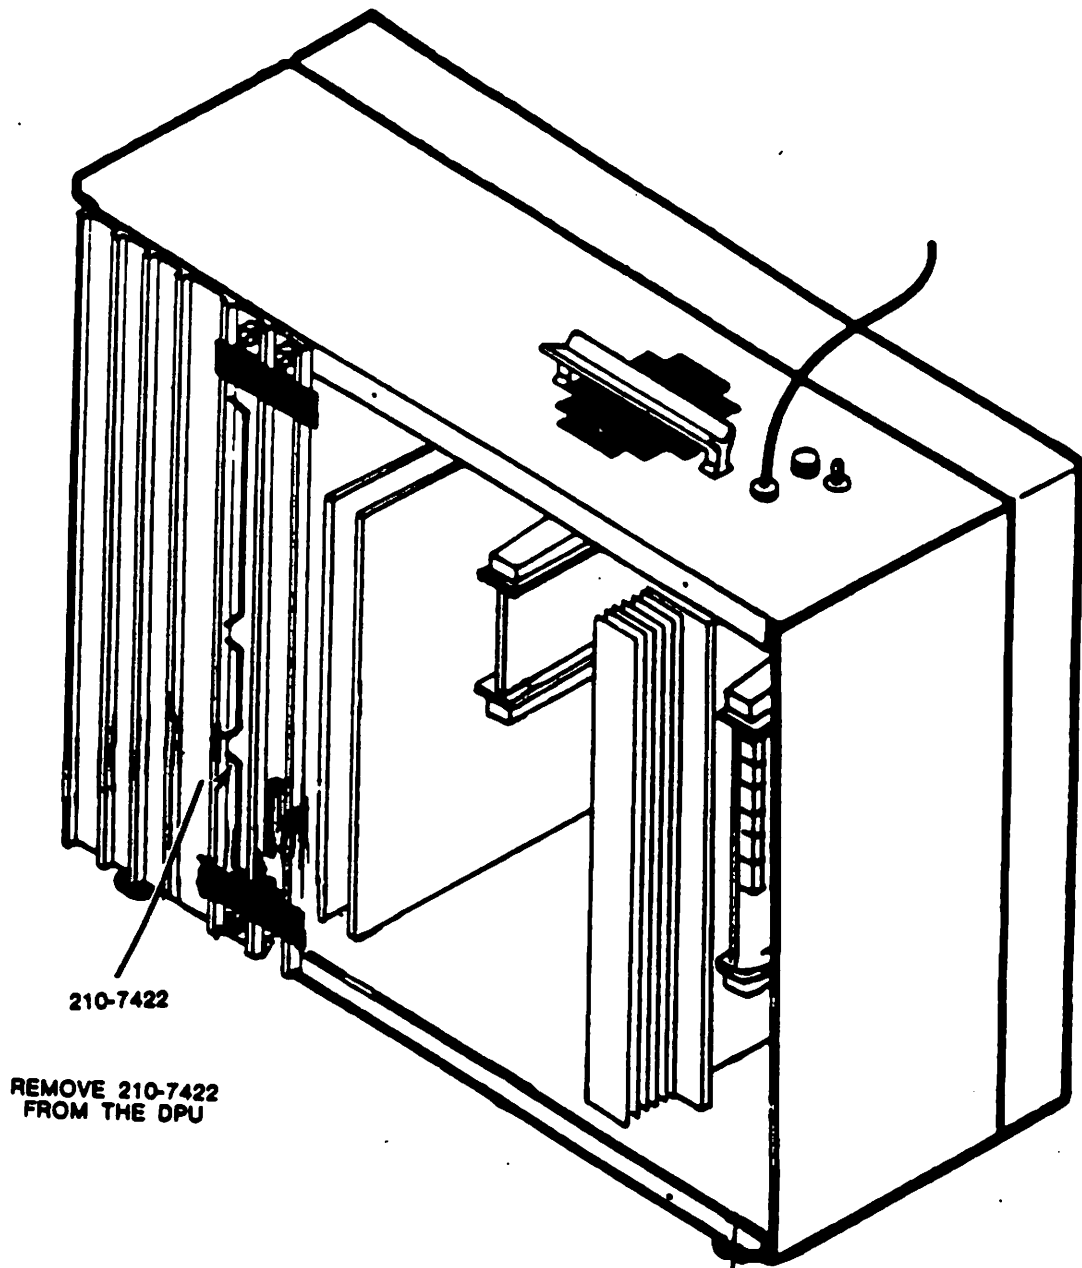
FIGURE 1: LOCATION OF 210-7422 PCB IN DPU

To correct start-up problems which result in DPU hangs by making sure that the state of the drives is properly determined before normal processing is continued. The hangs are caused by DPU registers left in an unknown state after trying to read the Alternate Sector Map from a non-existent disk.

- A. Power off. Remove AC from unit.
- B. Remove the top cover of the Disk Processing Unit (DPU). Refer to p. 4-3, Sections 4.5 through 4.5.1 of the Customer Engineering Product Maintenance Manual, "2280 DPU" (729-0971) for removal/replacement procedures.
- C. Remove the 210-7422 PCB from the DPU. (Figure 1)

- 2. Place E-Rev 5 sticker in upper right corner of board.
- E. Reassemble the unit by reversing Steps B and C.
- F. Perform check-out procedure described in Section 6 below.
- G. Document installation of this FCO by completing a Call Report or Activity Report.

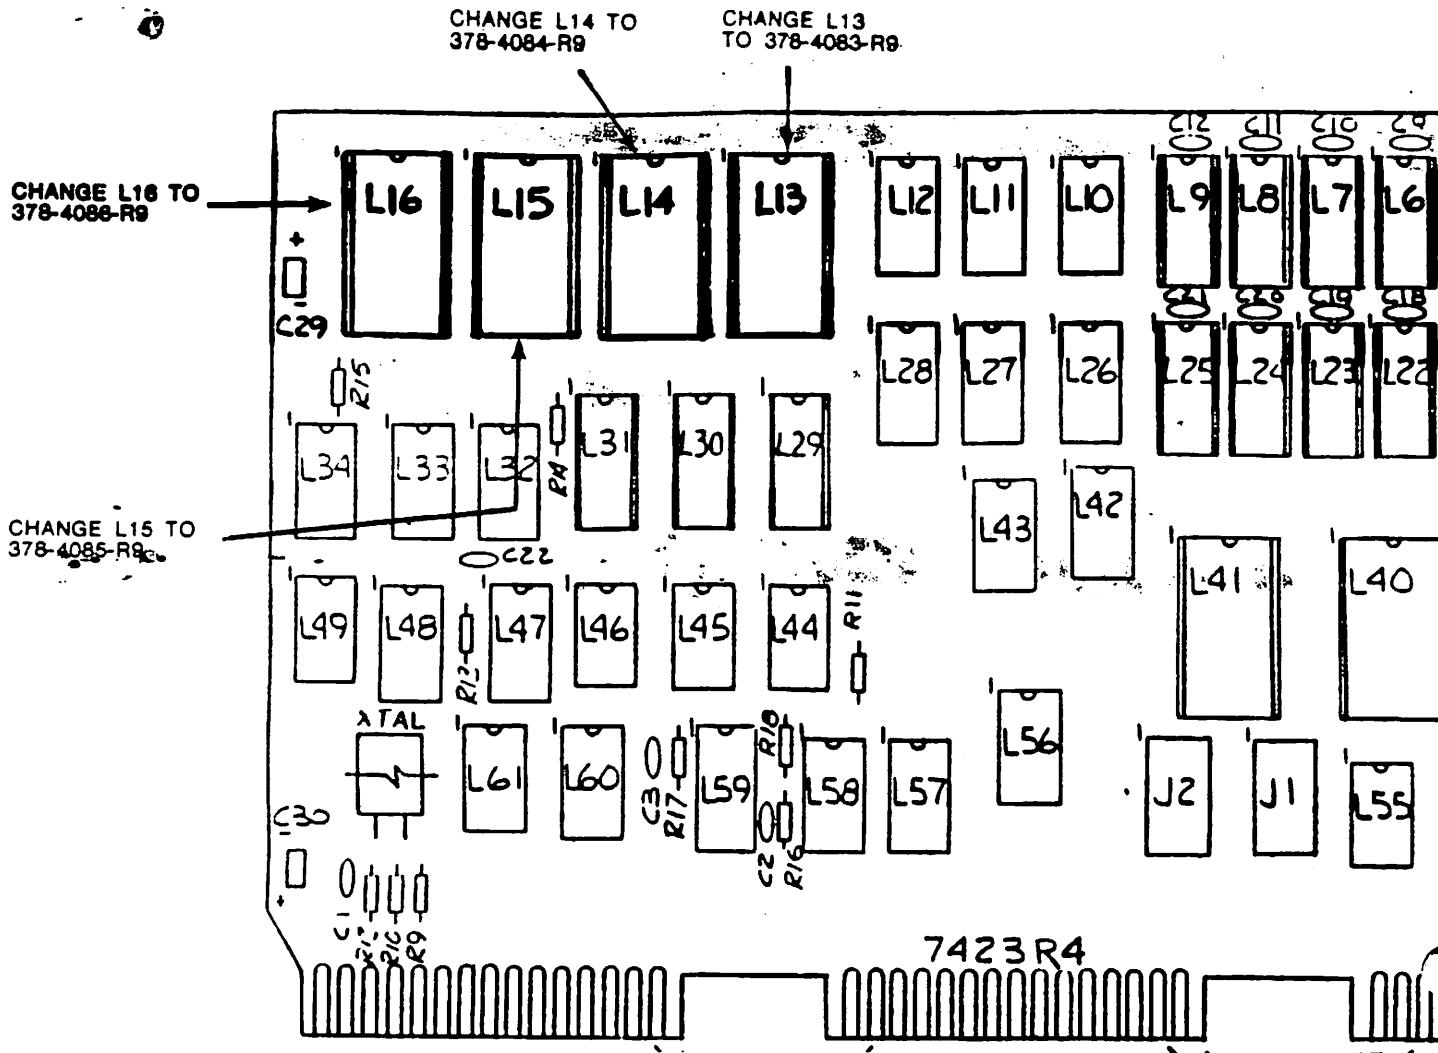
FIGURE 2: 210-7423-A EPROM LOCATIONS

To correct start-up problems which result in DPU hangs by making sure that the state of the drives is properly determined before normal processing is continued. The hangs are caused by DPU registers left in an unknown state after trying to read the Alternate Sector Map from a nonexistent disk.

- D. Refer to Figure 1. Remove the 210-7423-A PCB from the Disk Processing Unit (DPU).
- E. Refer to Figure 2. Change the four EPROM's on the 210-7423-A PCB as follows:
  - 1. Component Side:
    - a. Change L13 to 378-4083-R9.
    - b. Change L14 to 378-4084-R9.
    - c. Change L15 to 378-4085-R9.
    - d. Change L16 to 378-4086-R9.
- F. Reformat all surfaces.
- G. Reassemble the unit by reversing the procedures in Steps B through D.
- H. Perform check-out procedure described in Section 6 below.
- I. Reinstall customer's data.
- J. Document installation of this FCO by completing a Call Report or Activity Report.
