IMMEDIATE  
SERVICE  
NOTICE

NO. 179A

SUBJECT  
2236 MXD AT 19.2K BAUD. ECN'S

THIS ISN REPLACES ISN 179.

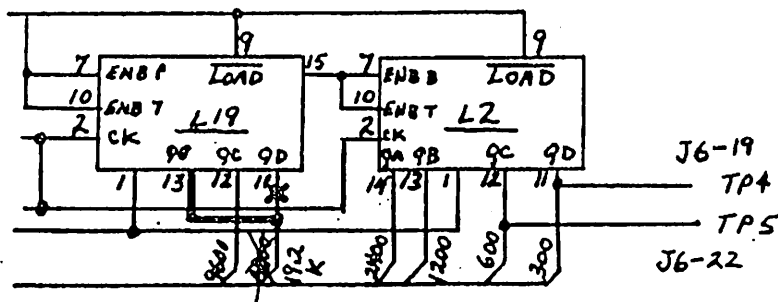
1. 210-7290-1 (ECN 9447)

Recently, hardware changes were made to the 210-7290-1 and 210-7292-1 boards which allow the 2236 MXD system to operate at a baud rate of 19.2K only when both changes are incorporated. This ISN will explain the changes to both boards, in order that existing 2236 MXD systems may be converted to 19.2K baud. Read this ISN completely before making any changes.

- A. Isolate L19 pin 11 from the etch that connects it to the baud rate switches.
- B. Tie L19 pin 13 to the etch that was connected to L19 pin 11.
- C. Change E-REV from 0 to 1.

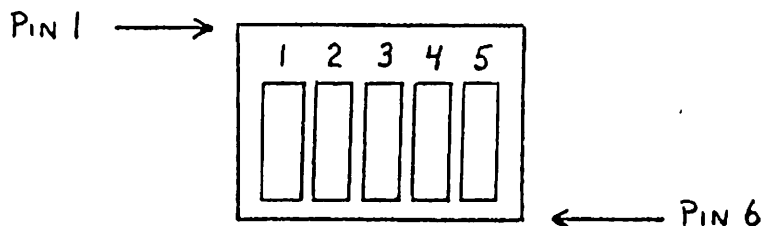
1. If location 7A is occupied by a 74175, return the board to the Home Office.
2. The square plate through designating pin 1 of SW 1 is actually pin 6.

- SW 1 pin labeling on old schematics is wrong.
3. If pin 9 of SW 1 is occupied by Parity Inhibit (PI), move the wire that is connected to SW 1 pin 9 to SW 1 pin 10. With Parity Inhibit tied to pin 10 of SW1, the board will conform to the new schematics.
  4. For 19.2K baud, the switch (SW1) must be set as follows:

<u>SWITCH #</u>	<u>STATE</u>
1	ON (to allow parity errors)
2	ON
3	ON
4	OFF
5	ON
