## 2280 DPU HARDWARE

### PROBLEMS:

I-90 ERRORS, DPU/SYSTEM HANGS, INCORRECT DRIVE SELECTED.

**WANG****ECO****ECO NO. 36643**

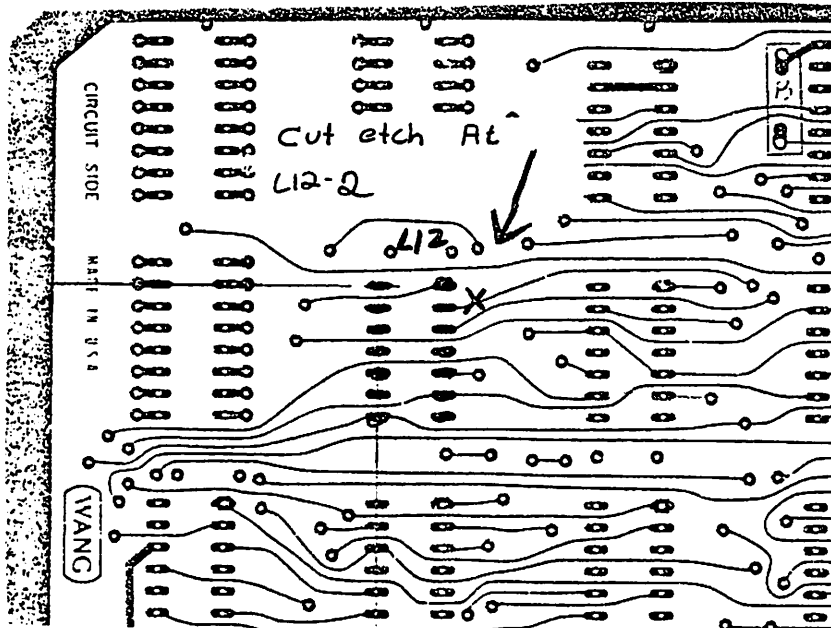
NOISE ON SYNC-BYTE CAN CAUSE FORMAT ERRORS.

Procedure

1. CHANGE L43 FROM A 74S20 TO A 7420 ( WL#376-0004 ).
2. JUMPER L31-8 TO L23-11.
3. JUMPER L31-9 TO L23-12.
4. JUMPER L31-10 TO L43-1.
5. JUMPER L23-13 TO L22-13.
6. CUT ETCH AT BASE OF L12-2.

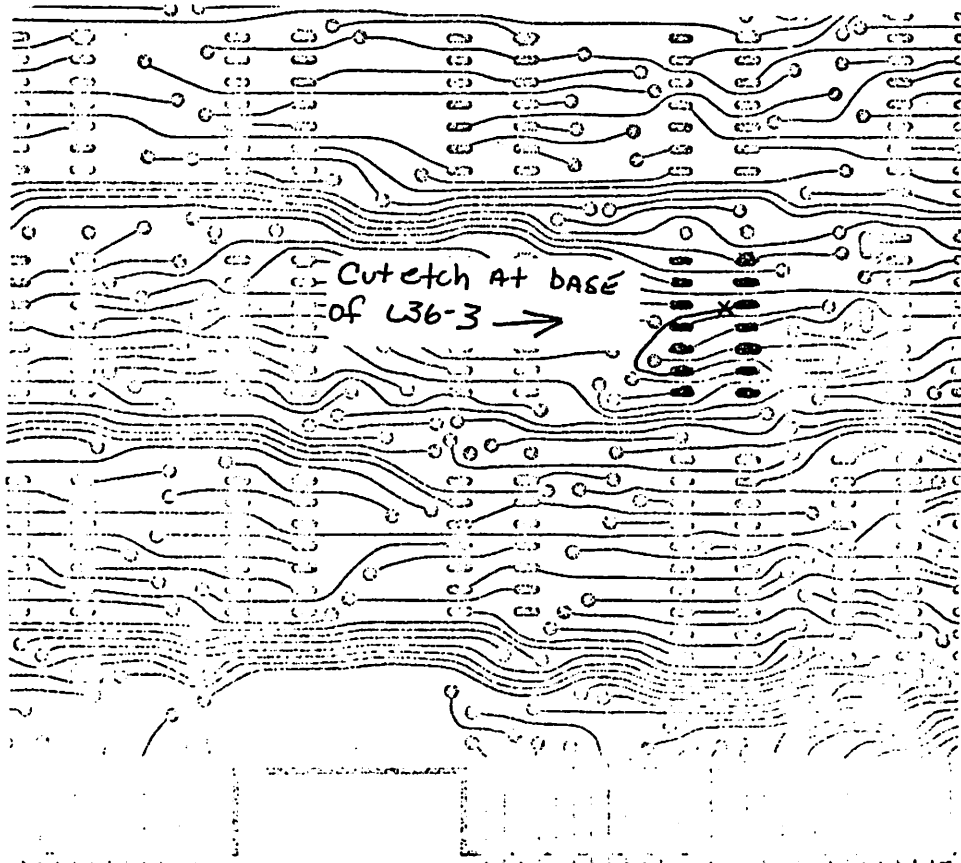
ARTWORK ERROR CAUSED TIMING TO BE OUT OF SPEC THEREFORE SOME  
DISK DRIVES COULD NOT BE SELECTED BY THE 2280.

NON-COMPONENT SIDE

2. CUT ETCH CONNECTING L36-3 TO L36-9.

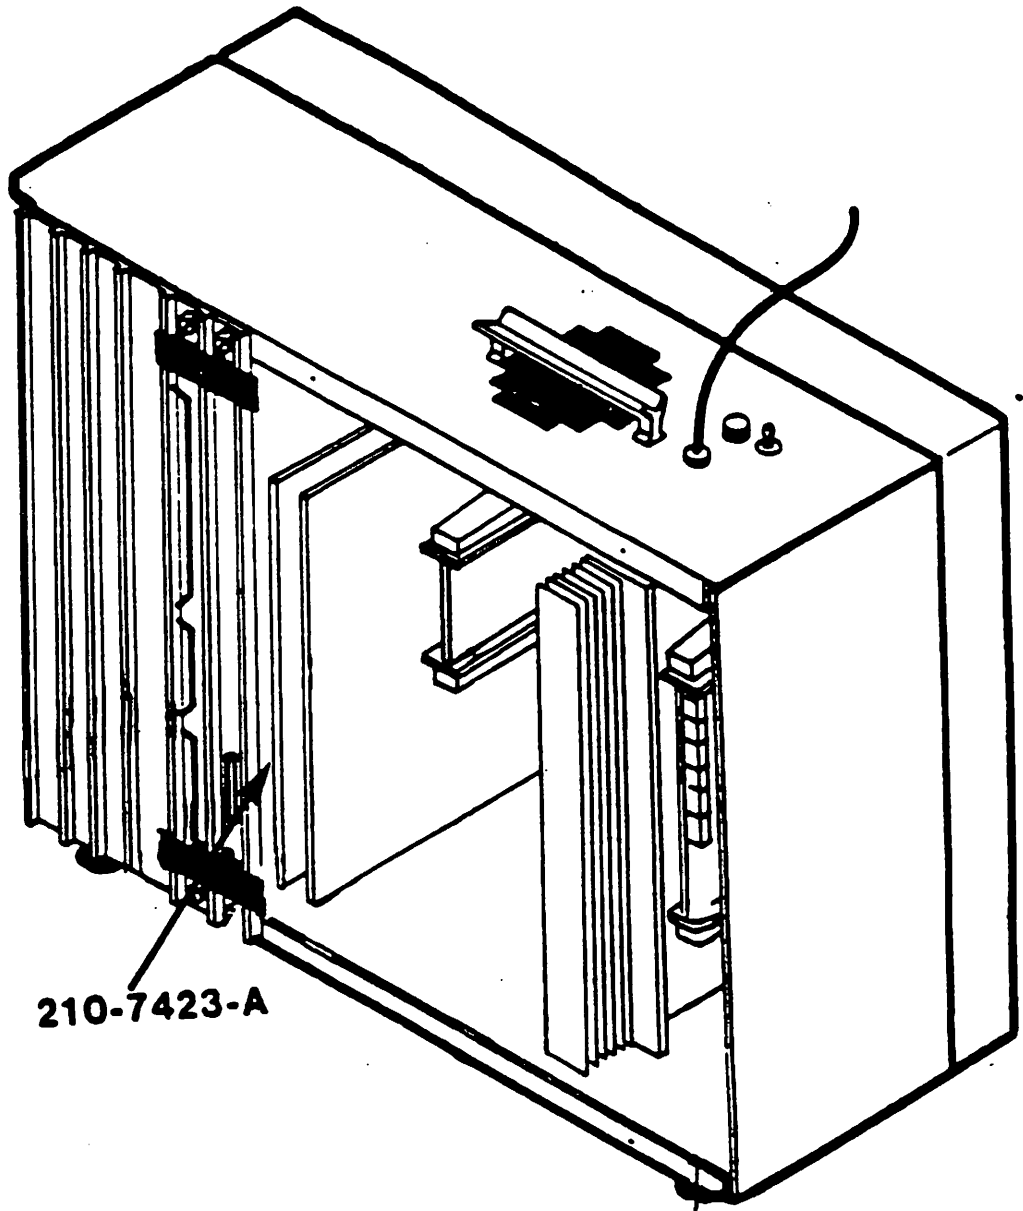
FIGURE 1

To correct start-up problems which result in DPU hangs by making sure that the state of the drives is properly determined before normal processing is continued. The hangs are caused by DPU registers left in an unknown state after trying to read the Alternate Sector Map from a non-existent disk.

- A. Power off. Remove AC plug at wall.
- B. Refer to "2280 DPU Customer Engineering Product Maintenance Manual" (729-0971) p. 4.3, sections 4.5 through 4.5.1 for top cover removal/replacement procedures.
- C. Refer to Figure 1. Remove the 210-7423-A PCB from the Disk Processing Unit (DPU).
